VACUUM JACKETED UMBILICAL LINES TECHNOLOGY ADVANCEMENT STUDY

BURST DISCS

November 1969

Final Report, Task I Contract Number NAS 10-6098

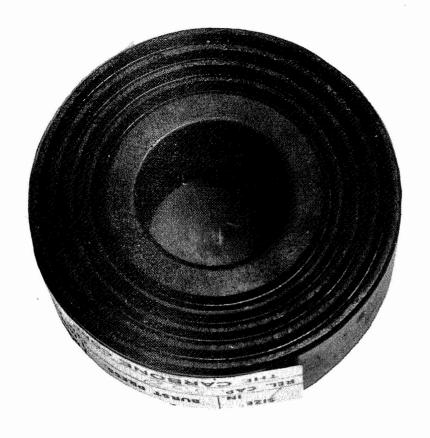
Figure 6. Carbon Rupture Disc

1 In. Dia. Flow Opening Burst Pressure Max. 26.25 psi Min. 23.75 psi

Carbon Rupture Disc (Courtesy of Carbone Corporation)

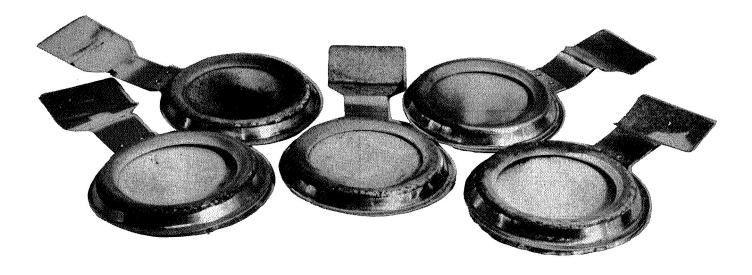
Note Sealing Surface Unaffected by Corrosion Burst Press — 32 psia

> Aluminum Pre-Bulged Rupture Disc (Removed From A Vacuum Jacketed Storage Vessel)

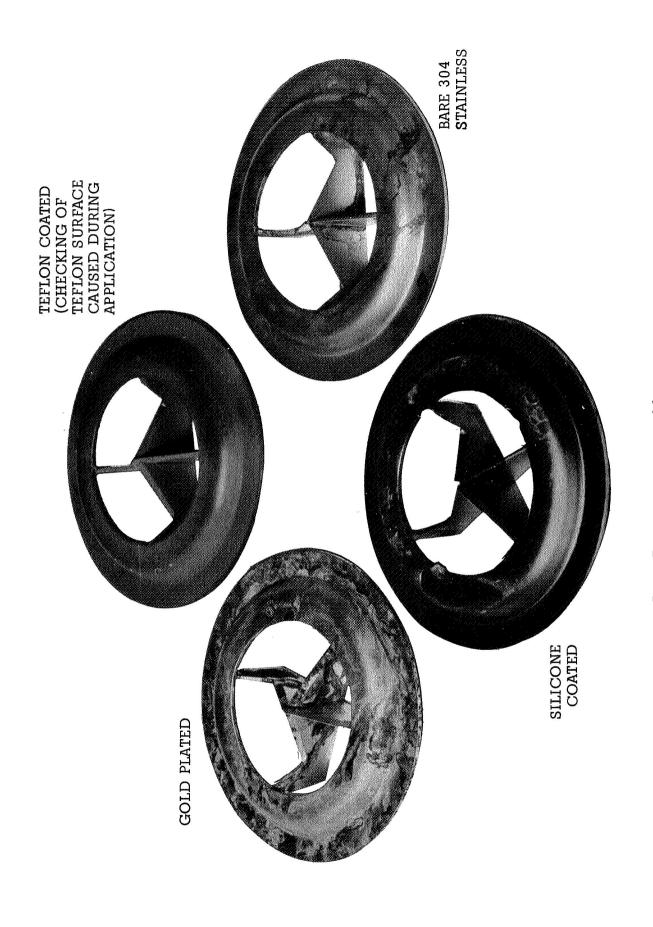
Figure 28. Salt Fog Test - Burst Disc Cutters

Burst Disc Cutter Assemblies 304 Stainless — After Salt Fog Test

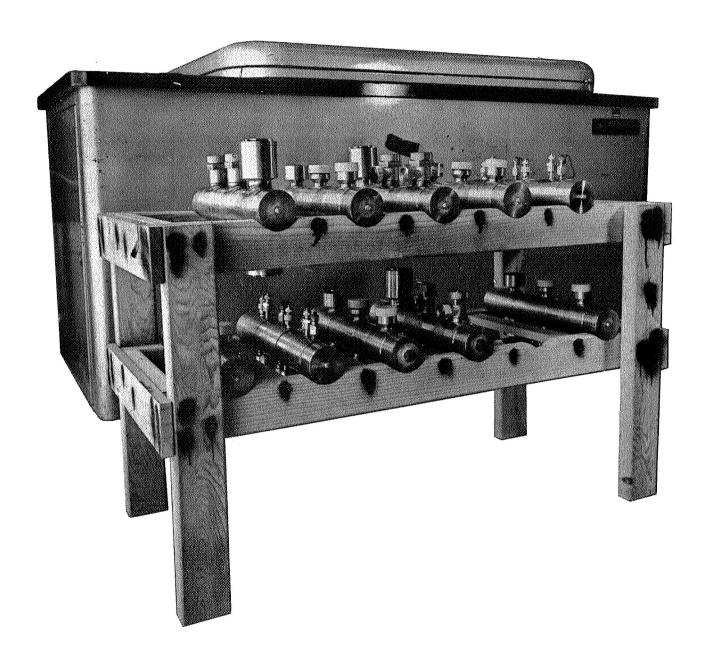
Figure 31. Salt Fog Test Manifold Rack

Salt Fog Chamber and Test Manifold Support Rack

All burst disc assemblies completed salt fog tests. (See Figures 31 & 32). No internal corrosion was found on any of the burst disc specimens. Light corrosion occurred on test fixture/specimen interface welds and spanner wrench holes. (See Figures 33,34 and 35).

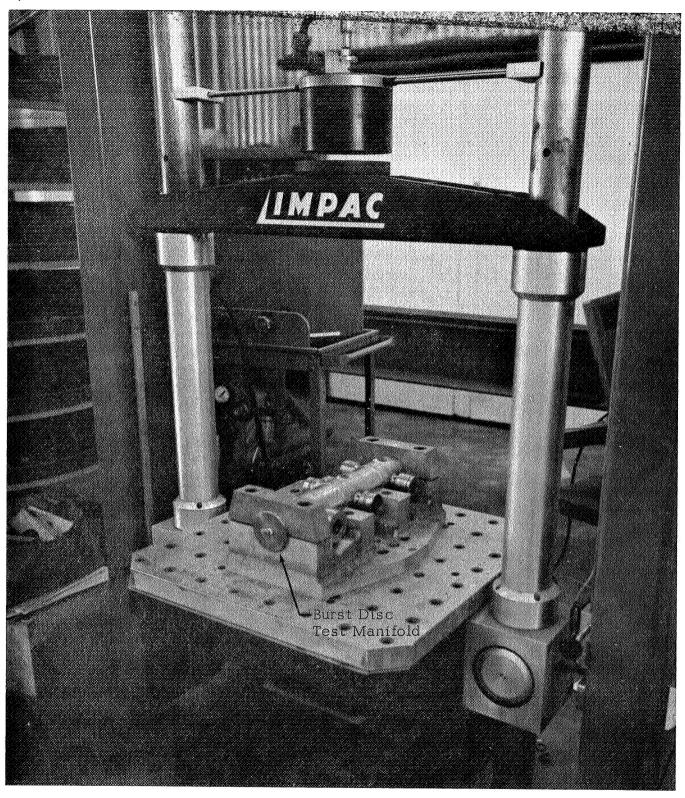
Figure 46. Shock Test Set-Up - Burst Discs, Z Axis

Shock Test Set-Up Burst Discs Z Axis

The shock tests were completed for all burst disc assemblies. None of the specimens tested incurred structural damage as a result of the test. No leakage was detectable during the functional test on any specimen. See Figures 45, 46 and 47. They show the test units following testing in the X, Y and Z axis respectively.

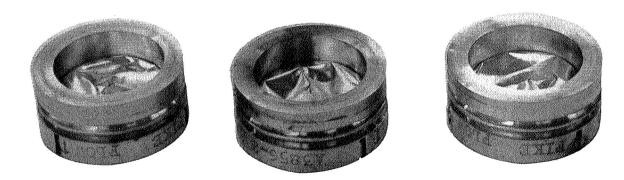
Figure 57. Burst Test - Fike Burst Discs

Each Specimen Buckled At 10 psi — Ruptured at 20-21 psig

NOTE: That buckling did not occur across total surface due to damaged surface

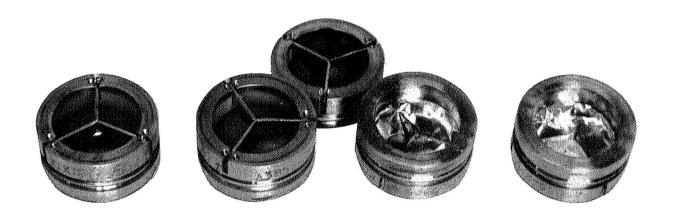
Note Complete Penetration Of Cutter Into Disc Diaphragm

Rated Burst Pressure — 29 psig All Specimens Burst Within ±8 psig

Fike A 3856-1 Burst Disc — Replaceable Assemblies Burst Test Results
